AFRL-ML-WP-TR-2000-4118

**LARGE AIRCRAFT COATINGS FLIGHT
TESTING**

**SOUTHWEST RESEARCH INSTITUTE -- DAYTON
P.O. BOX 31009
DAYTON, OHIO 45437**

FINAL REPORT FOR 03/01/1997 -- 02/29/2000

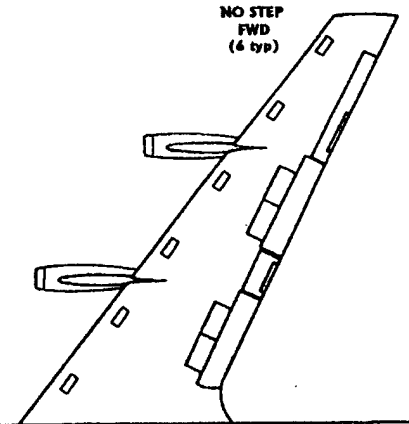
General Information			
Today's Date		Aircraft Type	
Inspector		Serial No.	
Title of Inspector		No. of Flight Hours	
Date of Last Inspection			
Coating Information			
Painted by		Location	Date
Surface Preparation			
Primer	Manufacturer		Batch No.
Topcoat	Manufacturer		Batch No.
Exposure Conditions			
Avg. Ground Temp.	>80° F. <input type="checkbox"/>	50° -80° F. <input type="checkbox"/>	<50° F. <input type="checkbox"/>
Avg. Ground Humidity	> 80% RH <input type="checkbox"/>	50 % - 80% RH <input type="checkbox"/>	<50% RH <input type="checkbox"/>
Avg. Ground Light	Outside <input type="checkbox"/>	Hanger <input type="checkbox"/>	Mixed <input type="checkbox"/>
Visual Inspection			
Area/Tests	Location / Substrate	Defect	Size (sq. in.)
Wing, Right - Upper Surface

*Test locations, as indicated in the Aerospace Coating Service Test Technical Evaluation Team Inspection Sheet, Appendix VIII, assess fluid resistance on the belly; locations on the wings determine UV degradation. Subsequent values obtained during later inspections were from nearby locations.

**Test locations on wing, as noted in Appendix VIII, measure UV degradation.

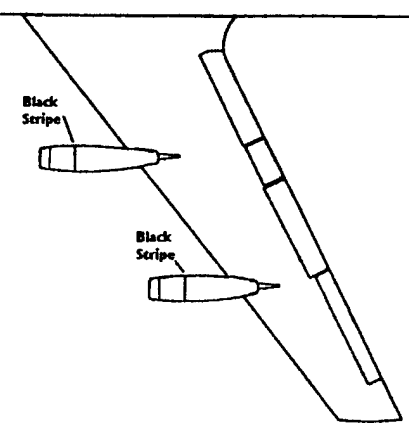
Erosion	
		Chipping	
		Blistering	
		Peeling	
		Chalking	
		Stains	
		Corrosion	
		Other(Specify)	
Wing, Right - Lower Surface

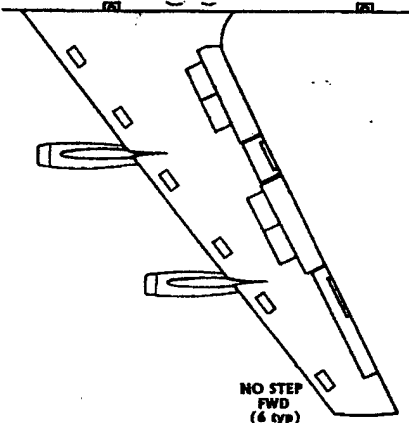
Area	Location / Substrate	Defect	Size (sq. in.)
Wing, Left - Upper Surface

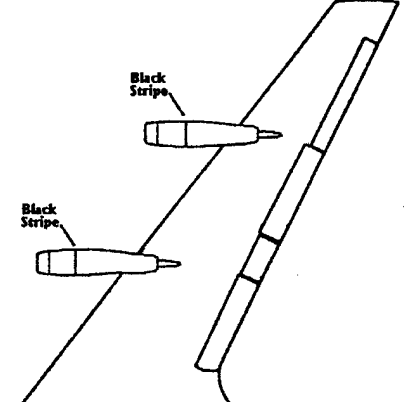
Erosion	
		Chipping	
		Blistering	
		Peeling	
		Chalking	
		Stains	
		Corrosion	
		Other(Specify)	
Wing, Left - Lower Surface

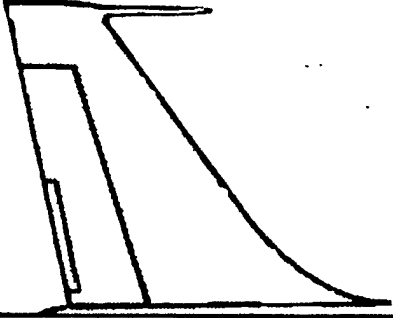
Area	Location / Substrate	Defect	Size (sq. in.)
Stabilizer, Vertical Right Side

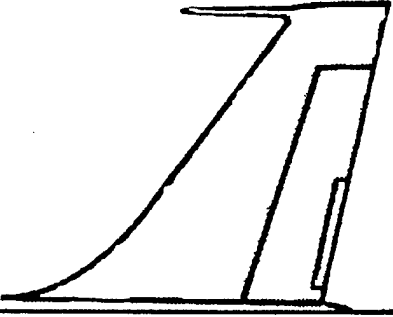
Erosion	
		Chipping	
		Blistering	
		Peeling	
		Chalking	
		Stains	
		Corrosion	
		Other(Specify)	
Stabilizer, Vertical, Left Side

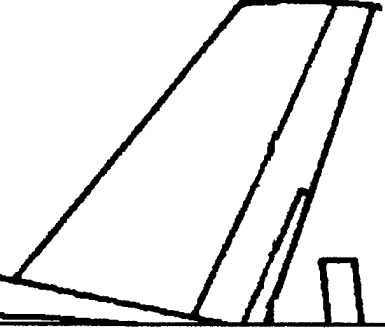
Erosion	
		Chipping	
		Blistering	
		Peeling	
		Chalking	
		Stains	
		Corrosion	
		Other(Specify)	
Stabilizer, Horizontal, Right Top Surface

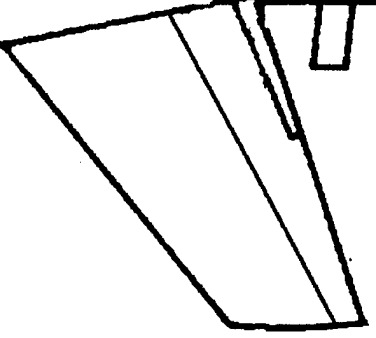
Erosion	
		Chipping	
		Blistering	
		Peeling	
		Chalking	
		Stains	
		Corrosion	
		Other(Specify)	
Stabilizer, Horizontal, Right Bottom Surface

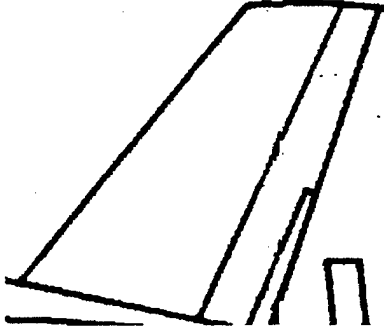
Area	Location / Substrate	Defect	Size (sq. in.)
Stabilizer, Horizontal, Left Top Surface

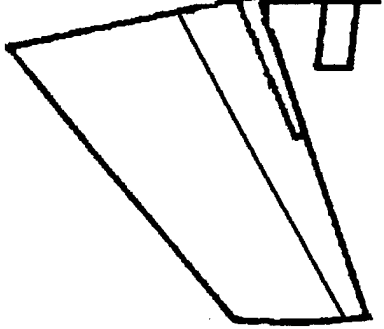
Erosion	
		Chipping	
		Blistering	
		Peeling	
		Chalking	
		Stains	
		Corrosion	
		Other(Specify)	
Stabilizer, Horizontal, Left Bottom Surface
